# Manhole Inspection Summary

Manhole # S13U\_\_003MH

Insp Date: **1/9/09 10:18 AM**

**Location** Address: **1100 Wilso Dr.**

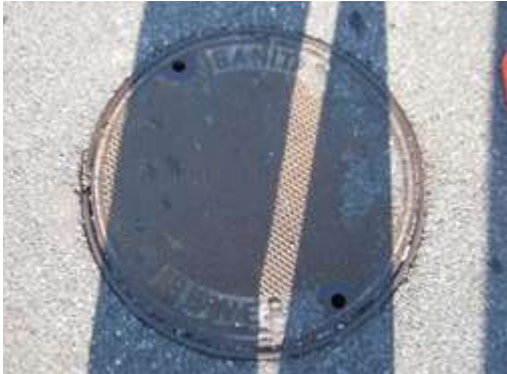
Misc

cover

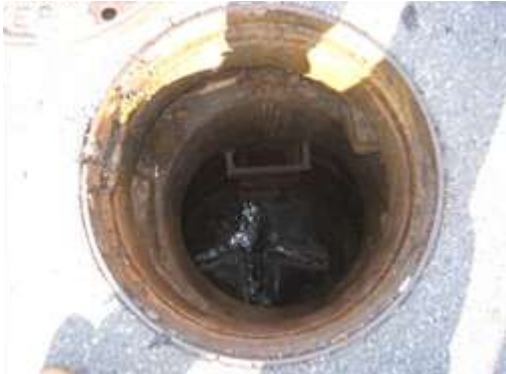
Misc

extra Top View

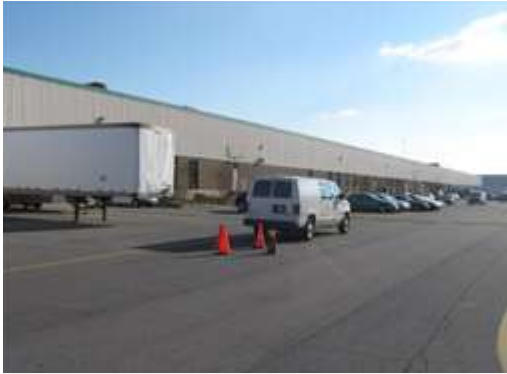
Misc

extra Location View

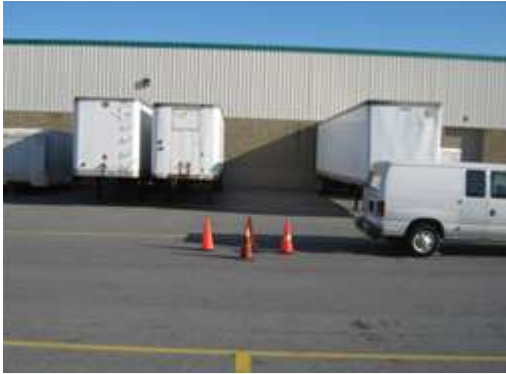
Misc

extra Location View

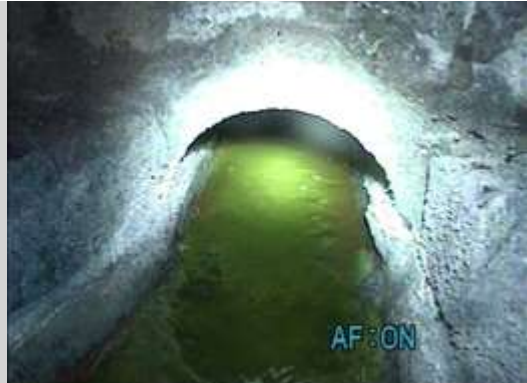
12 O'Clock Outflow

8 in. Circular Gravity Sewer  
Pipe Out @ 12 O'Clock

Pipe Height: **8.4** (in.) Rod and Bar (Angled)  
Pipe Material: **Clay** ☐ Pipe Lined  
Invert Depth: **11.70** (ft.) Flow Characteristics: **Slow**  
Deposits: ☒ None ☐ Mud ☐ Sludge ☐ Debris ☐ Grease  
Silt Depth: **0** (in.) Deposits Extent:  
Infiltration: **None** Pipe Seal Cond: **Sound**

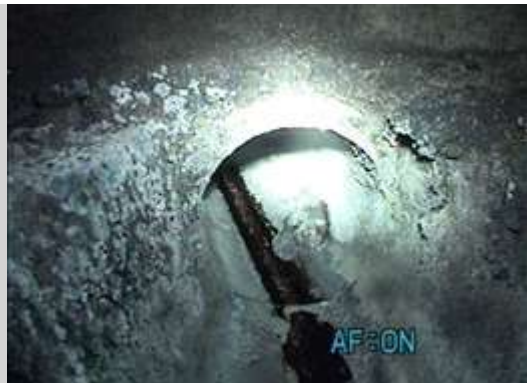
3 O'Clock Inflow

6 in. Circular Gravity Sewer  
Pipe In @ 3 O'Clock

Pipe Height: **6** (in.) Rod and Bar (Angled)  
Pipe Material: **Clay** ☐ Pipe Lined  
Invert Depth: **11.52** (ft.) Flow Characteristics: **None**  
Deposits: ☒ None ☐ Mud ☐ Sludge ☐ Debris ☐ Grease  
Silt Depth: **0** (in.) Deposits Extent:  
Infiltration: **None** Pipe Seal Cond: **Sound**

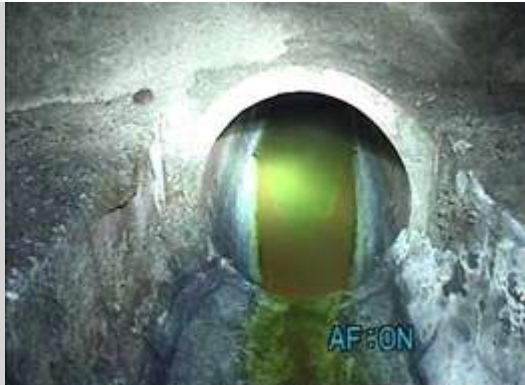
6 O'Clock Inflow

Pipe In @ 6 O'Clock

Pipe Height: **8.4** (in.) Rod and Bar (Angled)

Infiltration: **None** Pipe Seal Cond: **Sound**

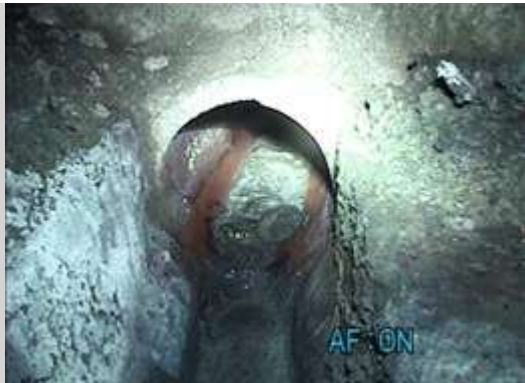
8 O'Clock Inflow

Pipe In @ 8 O'Clock

Pipe Height: **6** (in.) Rod and Bar (Angled)

Infiltration: **None** Pipe Seal Cond: **Sound**
